Advances in Research 8(2): 1-7, 2016; Article no.AIR.30096 ISSN: 2348-0394, NLM ID: 101666096

# Foundation Soil Characterisation for a Building with Multiple Cracks at Tarkwa, Ghana

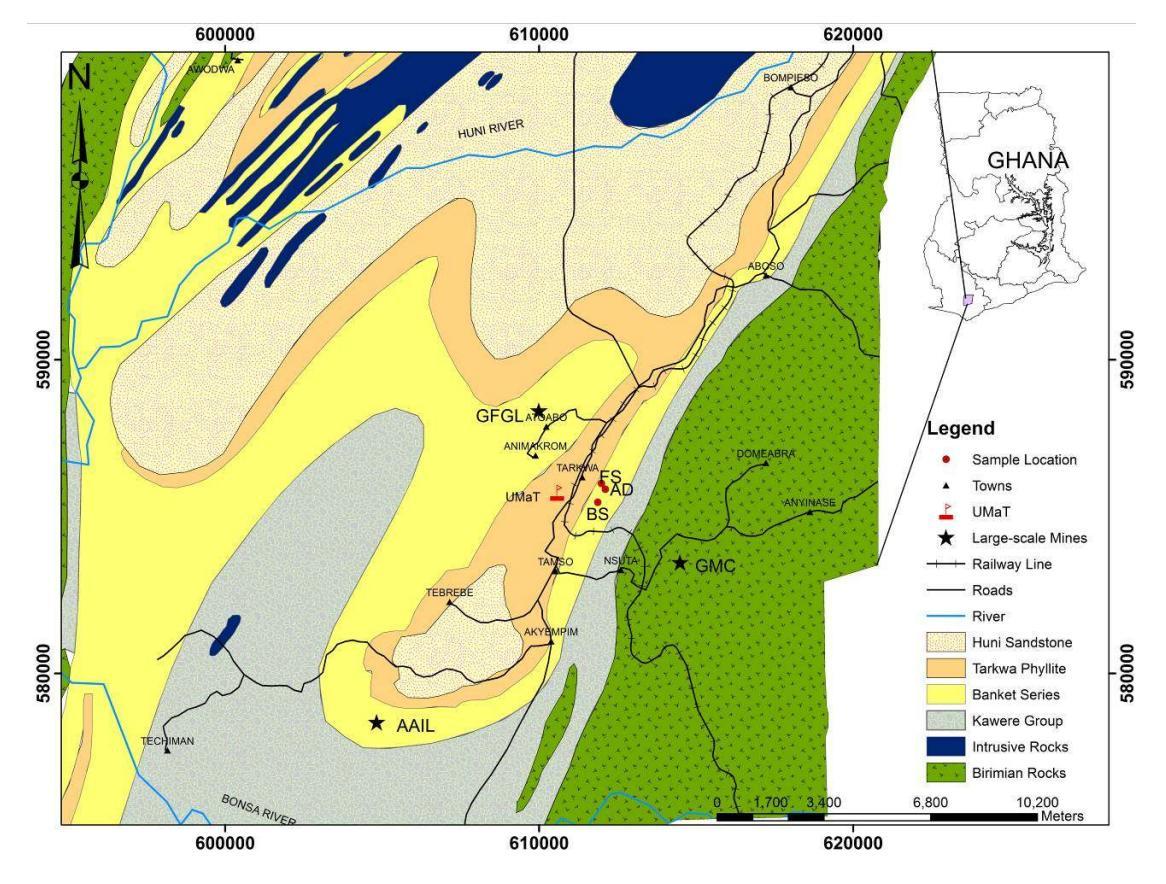
Fig. 1. Geological map of Tarkwa area showing sample locations (Modified after [6])

Soils at Tarkwa site, occurred on competent foliated quartzite intercalated with conglomerate of the Tarkwaian Banket Series (Fig. 1). Hence [4] linked the maximum stress direction on the rocks in the area to the minimum stress direction on the building that was at the site and interpreted cracks on the building to settling under maximum load of the building and possibly caused by slip during adjustment of foundation rocks toward mine openings.

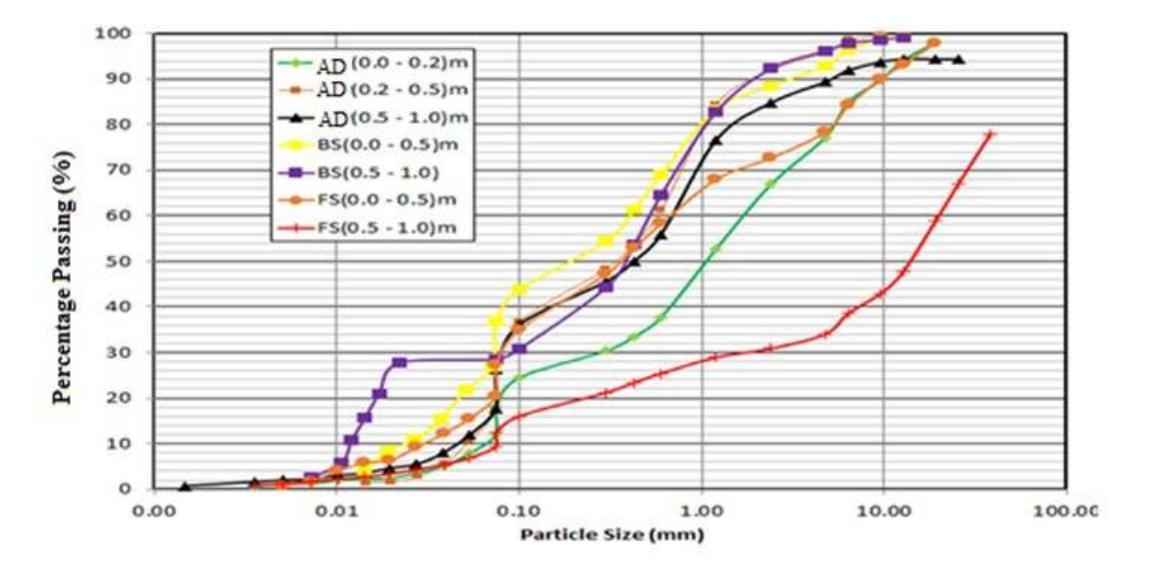
Fig. 2. Particle size distribution of soils at the Tarkwa site

The results of the laboratory tests are presented in Table 1 and distribution curves are shown in Fig. 2. From Table 1, samples from the surface to 0.5 m depth showed various proportions of silt, gravel and sand. Moisture content varied from 5.42% in sample BS to 9.08% in the sample at the site (FS), clay content varied from a minimum of 0.0 in samples BS and FS but highest in sample AD at 3.0%. Silt is lowest in sample FS (17.8%) and highest (72%) in sample AD; gravel content is minimum (0.4%) in sample AD and highest (28.2%) at the site (sample FS). An intermediate layer between 0.5 - 0.7 m depth occurred near the adit which was made up of gravelly, silty sand (gravel - 9.8%, silt - 12.4%, and sand - 78.8%). This layer was non-plastic, contained moisture content of 11.45% and specific gravity of 2.64 Kg/m<sup>3</sup>.

The soil layer up to 1.0 m was made up of various types of soil proportions. The layers were uniform in depth (0.5 - 1.0 m) at the Basic School (BS) and the building site (FS) but at the adit area it was 0.7 - 1.0 m. The soils were made up of clay - 0.0 to 3.0% (sample AD); silt -12.2% (sample AD) to 24.0% (sample BS); sand - 22.8% (sample FS) to 69.2% (sample AD) and gravel - 10.0% (sample BS) to 69.2% (sample FS). The area is underlain by dense silty sand with admixtures of gravel and minor clay. The average moisture content was 8.9% with average specific gravity of 2.7 Kg/m<sup>3</sup>; typical of quartz sands. The plasticity index (PI) ranged from 1.5% to 7.8% with an average of 4.9% (Table 1). Fig. 3 shows that the soil at the site was mainly silt and non-plastic.
