Application of Deep Learning Techniques in the Development of Predictive Maintenance and Fault Detection in Electric Motors

Original Research Article

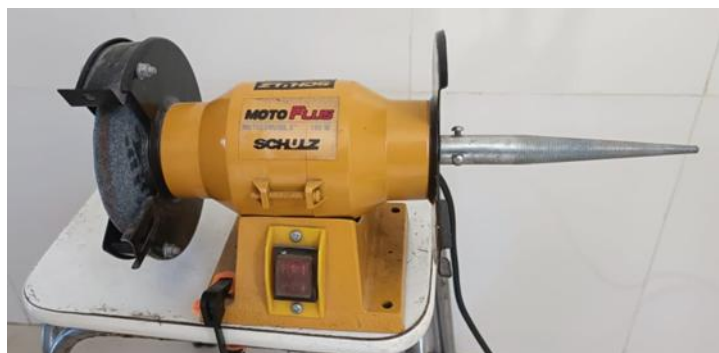
Fig. 1. Bench grinder used in the overheating study

To evaluate the deep learning technique associated with thermographic analysis, an experimental procedure was proposed to overheat an electric motor in a controlled manner without causing permanent damage to the equipment. Thus, the electric motor used was a bench grinder, as shown in Fig. 1. To modify the temperature profile of the motor, a resistive load was applied to rotation on the right axis of the equipment.

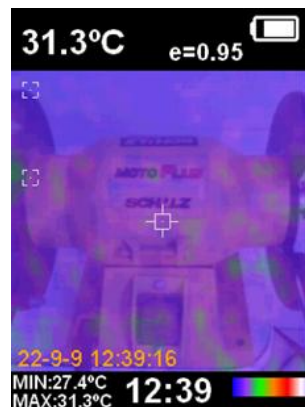
Fig. 3. Image taken by the thermographic camera

In Fig. 3, it is possible to see the option of the camera to superimpose the thermal images on the actual image of the object to facilitate the positioning of the tripod to take pictures. However, due to the low mass of the bench, it suffered small displacements from the base caused by engine rotation. Nevertheless, this noise did not impact the classification step of the temperature profiles.

Still, in Fig. 3, there is no significant color variation when it is turned off or at the beginning

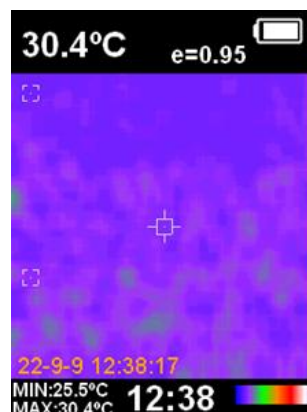
Fig. 4. Thermographic image at the start of the electric motor

of the motor rotation. To reinforce this point, Fig. 4 is presented, a photo taken shortly before Fig. 3, removing the overlap of the actual image.

As expected, Fig. 4 presents a homogeneous color pattern since the motor is turned off and its temperature is in thermal equilibrium with the environment. After a few seconds of rotation, the motor overheats forming the temperature profile without applying load.

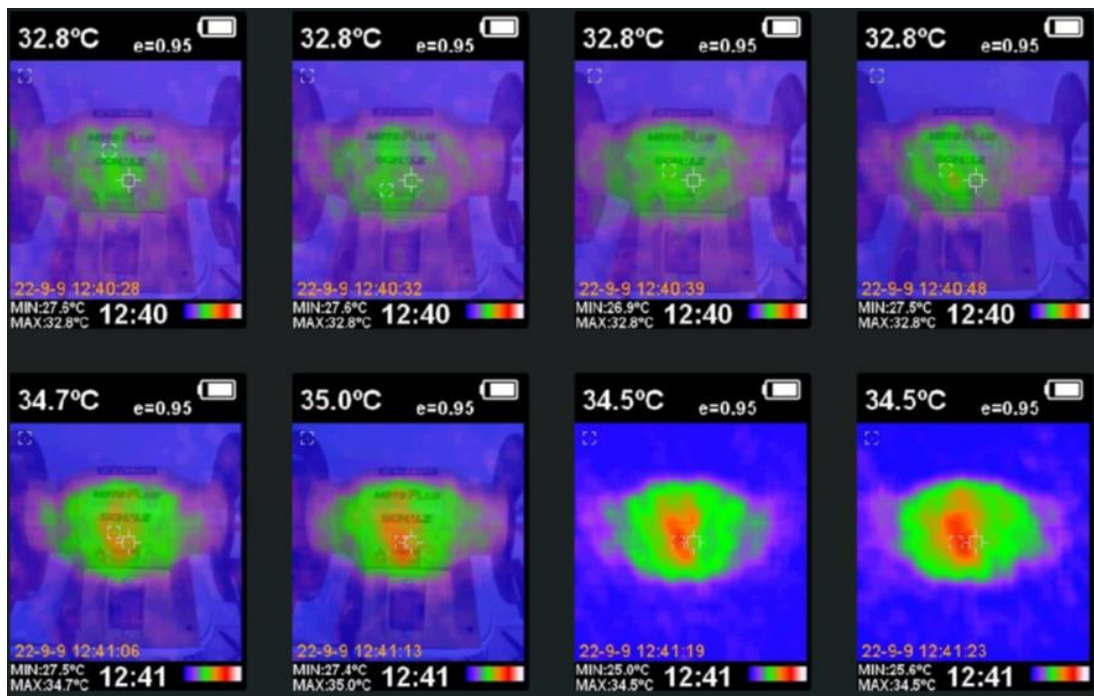
Fig. 5. Thermographic photos showing the temperature evolution of the engine at rest until the operation without load
