Comparative Analysis of Precast and *In situ* Concrete and Their Effectiveness on Koga Irrigation Structures

Original Research Article

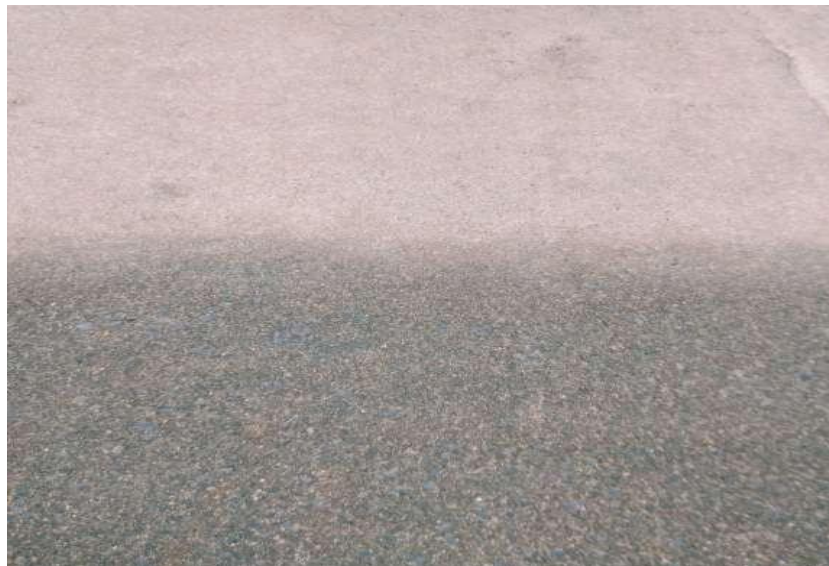
Fig. 3. Observation of concrete face above and below the free board

From the visual inspection results, it was observed that all part of the lined canal under the freeboard is subjected to light scaling. So, the light defect category of scaling is generalized throughout the longitudinal section of the canal lining below the freeboard. But the severe loss of mortar and more exposure of coarse aggregate is observed more at the *in situ* linings.

The light scaling defects are very significant and observed on both precast and *in situ* concrete linings throughout the longitudinal section under the freeboard of the canals. But the severe scaling defect is observed more on the *in situ* concrete linings. This defect occurs in concrete that does not have proper air entrainment and is continuously saturated.

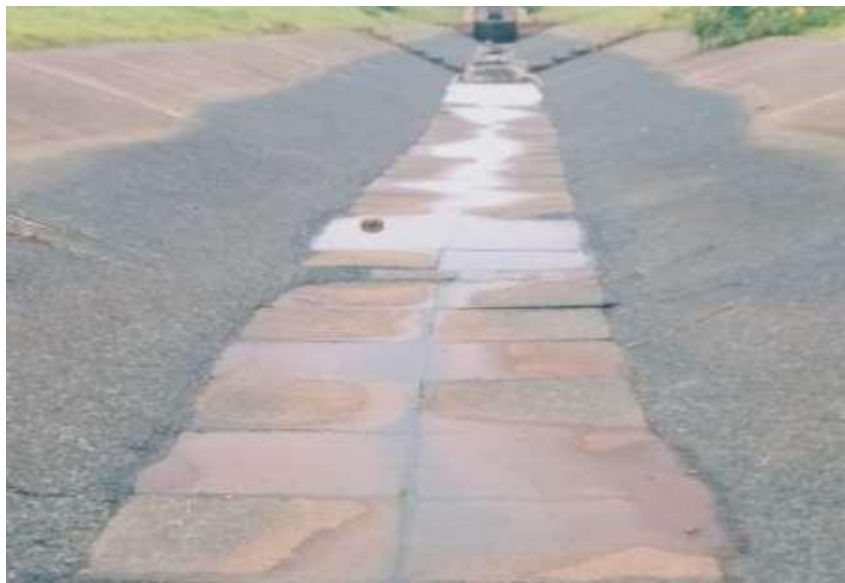
Fig. 4. Differential movements on the precast concrete

In most precast concrete canals, simple differential settlements were observed at the bed of the canal as shown in Fig. 4. But the *in situ* concrete passes the settlements as a slab.

The pop-outs and spalling defects can be taken as acceptable defects and insignificant problems. These problems will not further continue and are observed rarely in a few places only. In most precast concrete canals, simple differential settlements are observed at the bed of the canal. But the *in situ* concrete may bridge over those settlements.

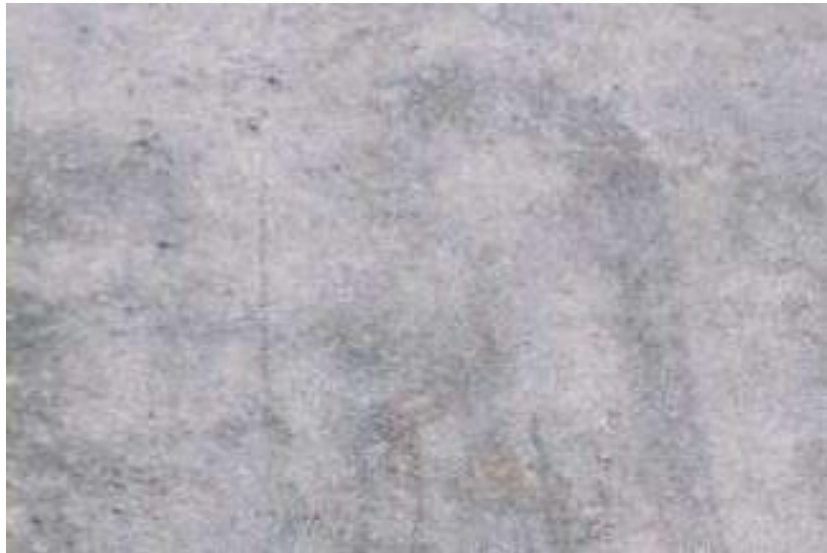
Fig. 5. Effect of rainfall on the *in situ* concrete

3.1.6 The effect of rainfall before setting of concrete on *in situ* sections

Properly placing, finishing, and curing concrete can have a big impact on service life. It is difficult to construct *in situ* concrete linings in the rainy season, because the rain may wash and erode the fresh concrete before its setting time. But in the case of precast concrete linings, the contractor can manufacture the precast elements in a rainy time in a protected room and assemble them during a dry time. Precast concrete linings are susceptible to the growth of grasses in the closely spaced joints. In the same manner, the cracks of *in situ* concrete are sensitive to the growth of grass and vegetation. The joints of precast concrete lining canals are scoured and removed.

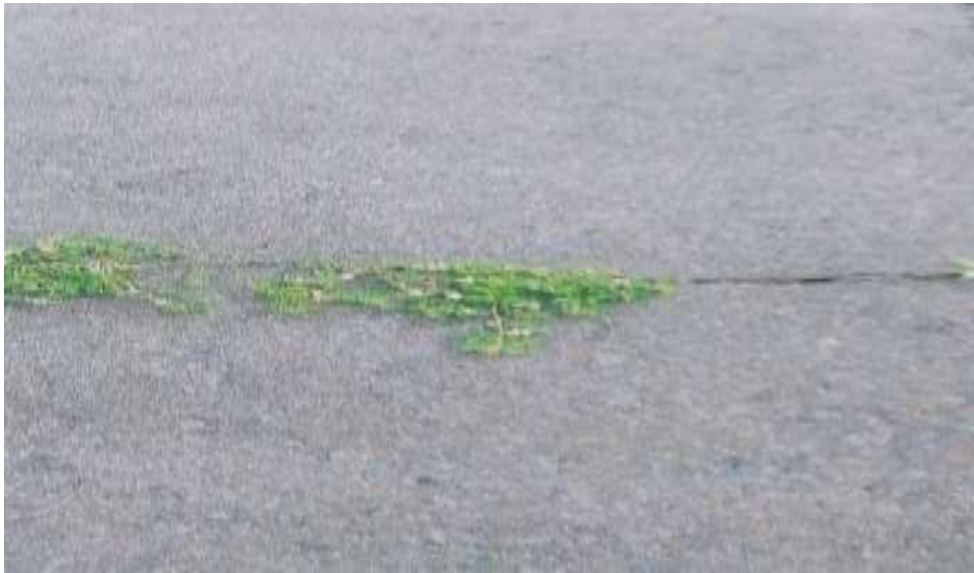
Fig. 7. Vegetation and grass growth in the cracks of *in situ* concrete

It was observed that Vegetation and grass have grown on the wider cracks of *in situ* concrete canal linings.

To prevent the occurrences of cracks on *in situ* canal linings, tensile reinforcement should be provided on the side slopes. Otherwise, such larger canals should be lined by precast concretes having watertight stronger, and more durable joints. Air-entraining admixtures must be added to the concrete mix to prevent freezing and thawing damages since the scaling defects are caused due to improper air entrainment and continuous saturation. Sub-surface and interceptor drains must be regularly maintained to prevent settlement, due to internal erosion or excess hydrostatic load. From the visual inspection, evaluating the extent of the damage must be done to know how much concrete has been damaged or in other words how long, how wide, how deep, and how much of the structure or lining needs maintenance.

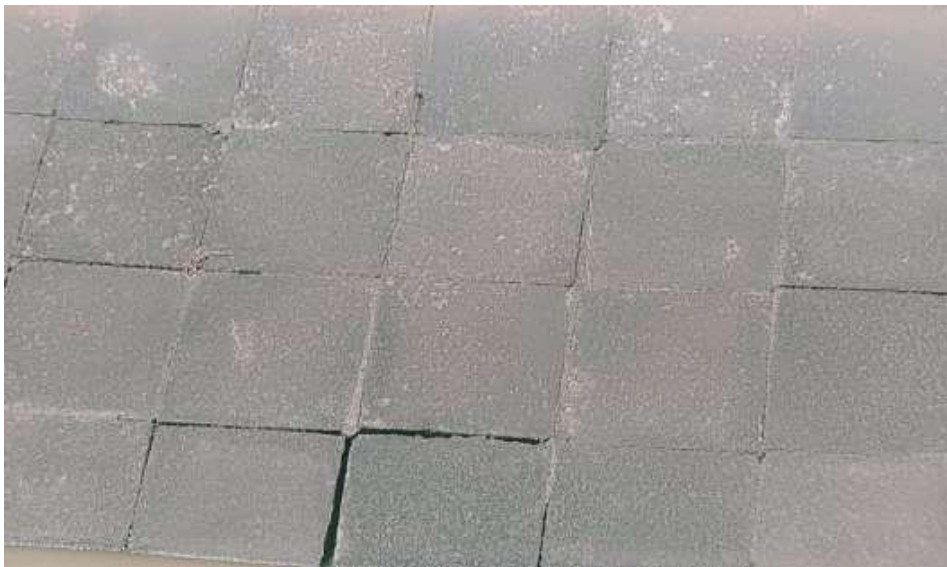
Fig. 8. Removal of joints between the joints of precast concrete

Some of the mortar-filled joints, which are the weak points of precast concrete canals, were removed by the scouring action of water (Fig. 8).

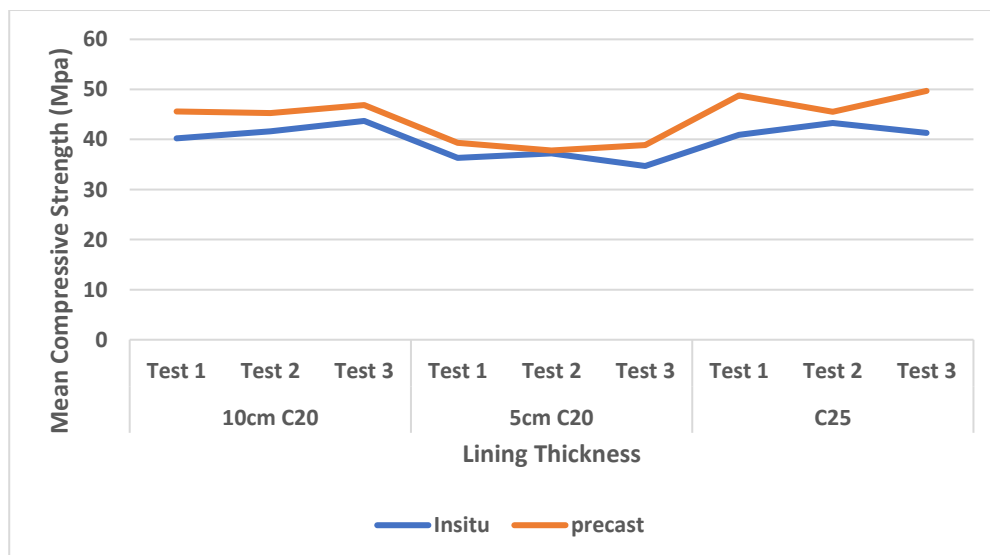
Fig. 10. *In situ* versus precast canal lining rebound test (Compressive Strength)

The compressive strength results of the rebound hammer test for different thicknesses of plain and reinforced concrete canal structures are summarized in Table 6. Generally, the summary

of the rebound test results from Fig. 10 shows that; the average compressive strength of the precast concrete part of the canal is much greater than that of the *in situ* concrete and the standard deviation of the compressive strength of the precast concrete is less than the *in situ* types of concrete. This is due to the high quality control of precast concrete in factory than cast *in situ* concrete which is done with low quality control in site compared to precast. The standard deviation of precast is also lower due to high quality control during production compared to cast *in situ* concrete.

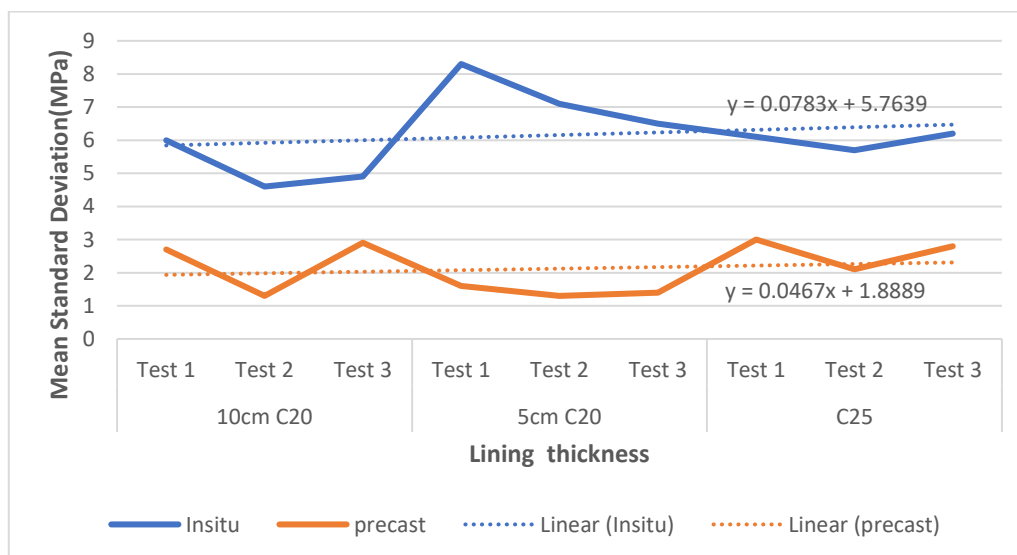
Fig. 11. Uniformity of the *in situ* versus precast canal lining

Precast uniformity is higher when compared with *in situ* concrete. As shown in Fig. 11, the trend line of *in situ* concrete is steeper than precast concrete. The standard deviation of the *in situ* is higher than precast concrete lining in all thickness levels as stipulated in Table 6; implying that precast has higher uniformity.
