Risk Identification of Lijiadagou Landslide and Debris Flow Hazards Chain in Yong'an Town, Fengjie County of Chongqing City

Original Research Article

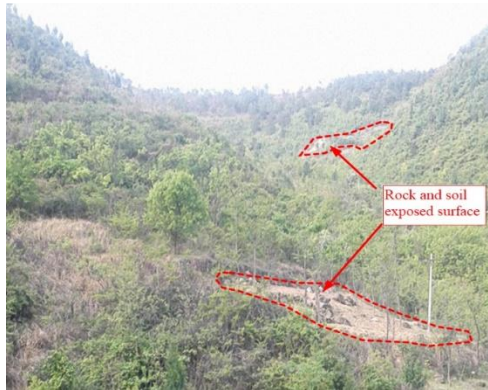
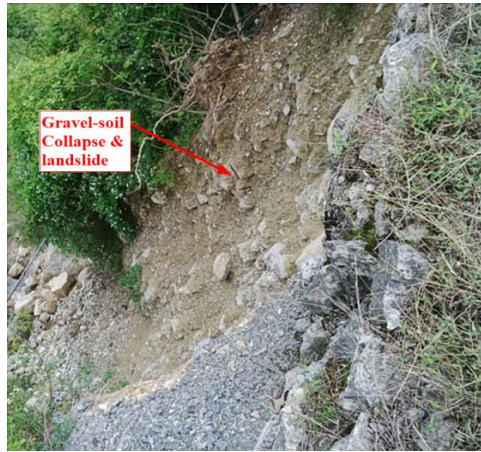
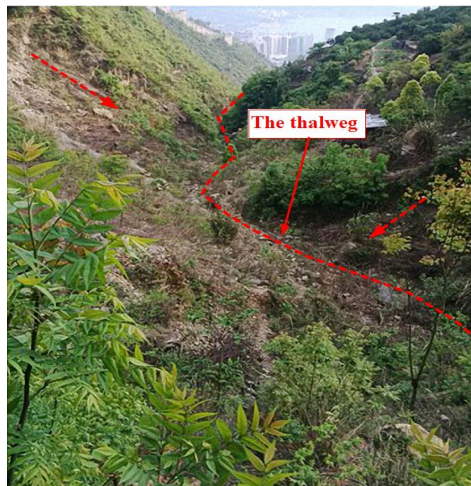
Fig. 4. Photograph of developmental features of Lijiadagou landslide and debris flow

strong scouring effect on the Quaternary loose materials on the gully bank, and the ditch bank collapses and slides, which also provides a large amount of solid source for the formation of debris flow, which may cause the gully to be blocked and the outburst may cause the sudden outbreak of debris flow. as shown in Fig.4.

(a) Topography and landform of the forming area

(b) Collapse and landslide of the gully bank in the circulation area

(c) Topography and landform of the circulation area

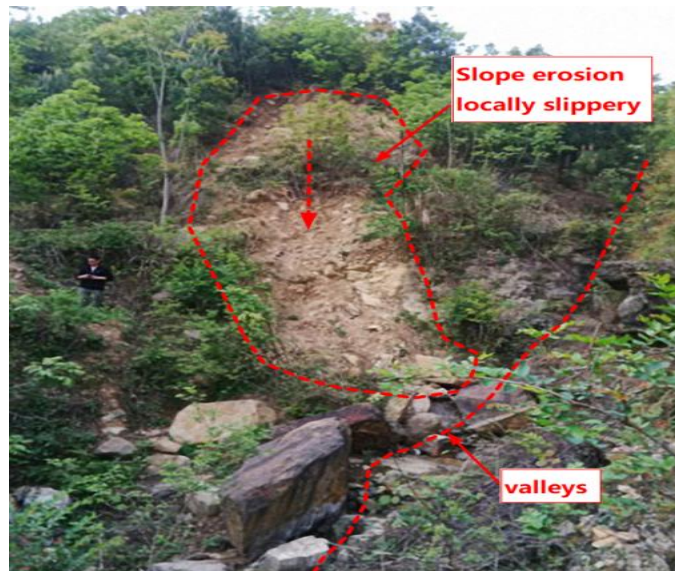
Fig. 6. Slope erosion and local slippery

The main geological causes of this kind of source materials are residual slope deposit, colluvial slope deposit, etc., which are mainly distributed in steep slope cultivation zone and barren zone. The soil erosion is relatively strong, and local sliding or slope debris flow generally occurs under the long-term scouring effect of surface water, which becomes the provenance of Lijiadagou debris flow. As shown in Fig.6, the total amount of slope erosion source is about $6.4 \times 10^4 \text{m}^3$.

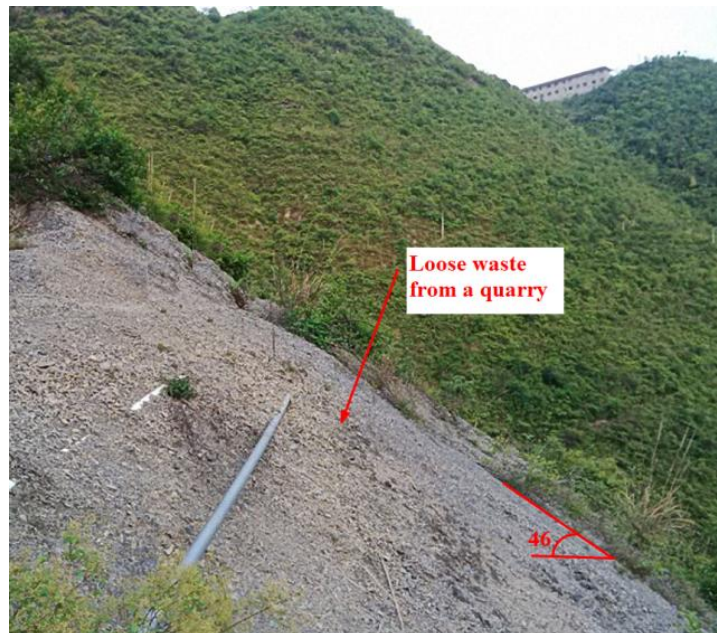
Fig. 7. Loose slag from the quarry

The artificial accumulation is mainly a quarry waste slag, located at the back edge of 3# branch ditch, the slope material is loose, the thickness is about 2 ~5m, and the total volume is about $1.8 \times 10^4 \text{m}^3$. It is easy to produce partial slippage or overall slippage under the action of

rainwater and become the source of debris flow, as shown in Fig.7.

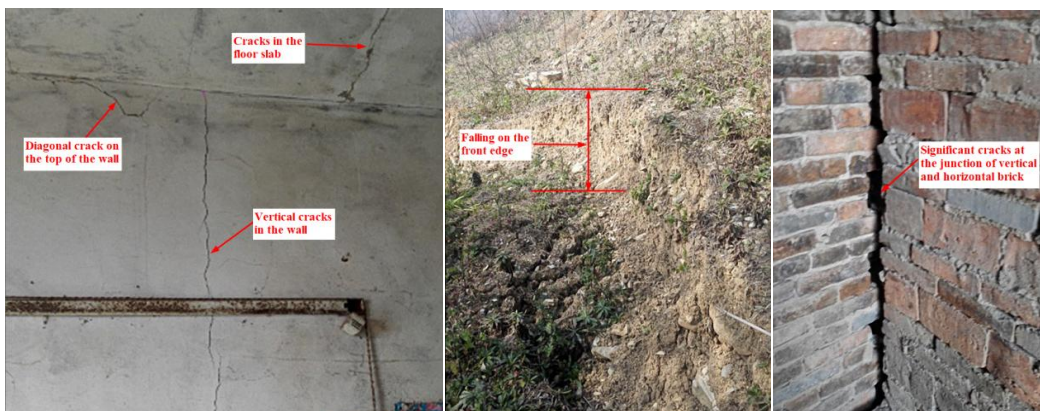
Fig. 9. Photo of house wall cracking and falling front edge within the range of Lijiadagou 1# landslide

The deformation of Lijiadagou (Gufang) 1# landslide began around 2012. After heavy rains during the flood season, the ground and residential buildings in the middle and rear parts of the landslide showed varying degrees of ground deformation and house cracks. The most recent deformation occurred after the heavy rain on August 31 in 2014, and the cracks on the ground at the middle and rear of the landslide increased (Fig.9).

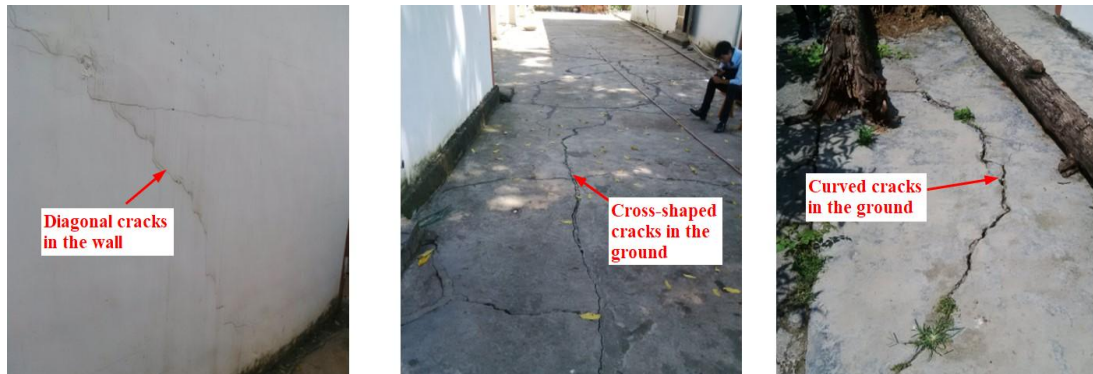
Fig. 11. Deformation of houses and roads within the range of Linjiawan landslide

According to the investigation, the deformation of Linjiawan landslide began around 2010. After the rainstorm during the flood season, cracks appeared in the residential houses in the front of the landslide. Since then, during the rainstorm or continuous rain, the surface and residential

houses in the landslide zone would be deformed to varying degrees. The most recent severe deformation occurred after a heavy rainstorm on August 31 in 2014, as shown in Fig.11.

The deformation of the Linjiawan landslide is mainly manifested as cracks in the walls of houses and ground cracks. It can be judged qualitatively that the current situation is basically stable, and it may develop to an unstable state or even instability under the condition of rainstorm and continuous heavy rainfall. The landslide mainly threatened the safety of the lives and property of 308 people in 83 households in the front part of the landslide, as well as 265 houses and 60 acres of arable land. The instability turned into mudslides and threatened the urban area. Based on the above analysis, it is recommended to carry out engineering treatment and effect monitoring on Linjiawan landslide [10].

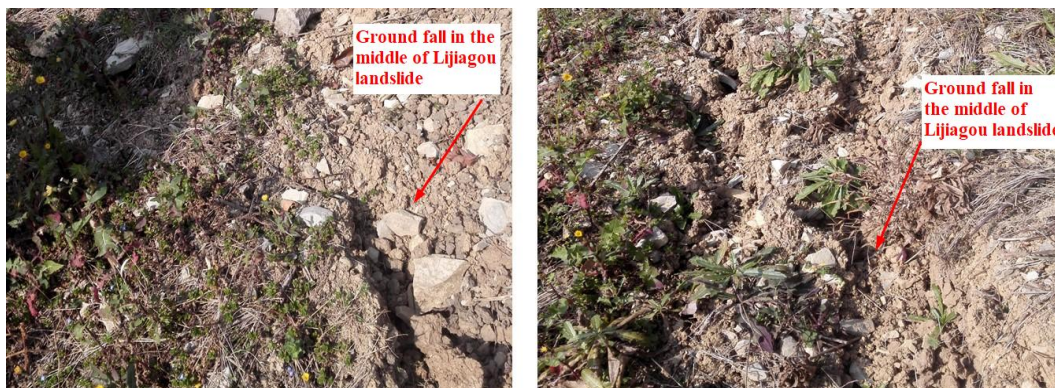
Fig. 13. Photograph of ground fall in the middle of Lijiagou landslide

The deformation of the landslide began around 2010. After the heavy rains during the flood season, the ground surface deformation and dislocation occurred in the middle of the landslide. The most recent deformation occurred after the heavy rain on August 31 in 2014, and

the ground in the middle and rear part of the landslide showed a significant surface drop, as shown in Fig.13.

The deformation of Lijiagou landslide is mainly manifested by the surface cracking and dislocation, and it is currently in the creeping deformation stage as a whole. It can be judged qualitatively that the current situation is basically stable, and it may develop to an unstable state or even instability under the condition of rainstorm and continuous heavy rainfall.
